# Accident Report

## Avalanche Accident

Fridtjovbreen – Marcussenfjellet

20. February 2020

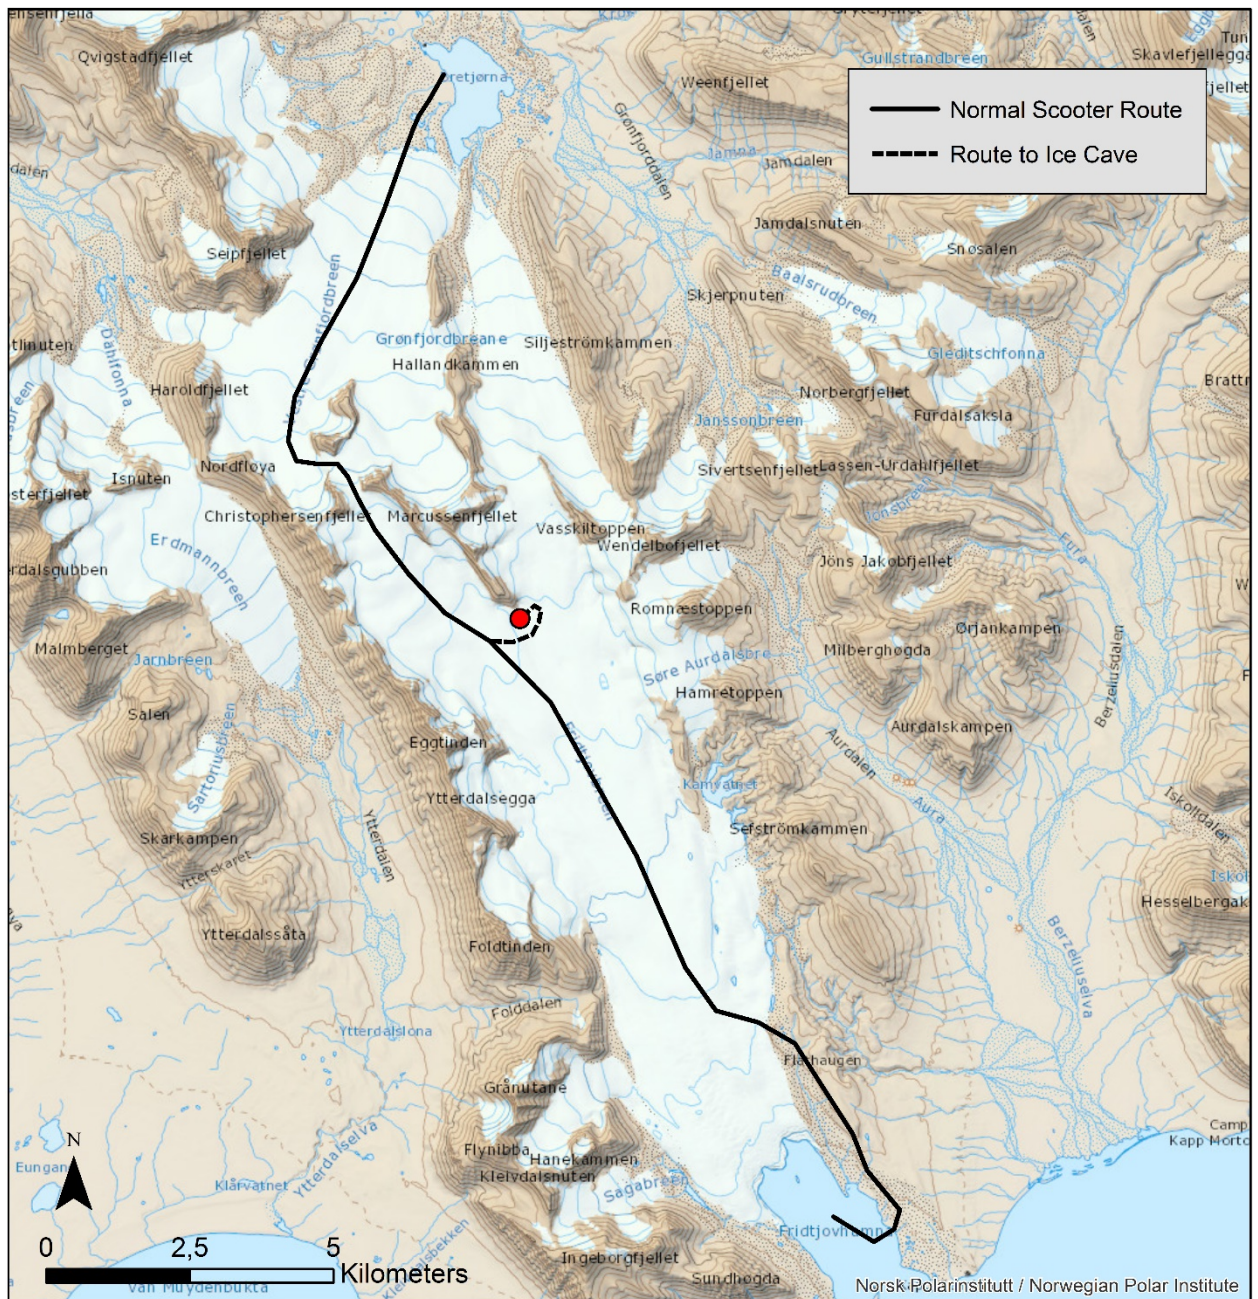
**Figure 2: The black line marks the normal route to follow when driving on Vestre Grønnefjordbreen and Fridtjovbreen. The position of the avalanche is marked with a red dot. The dashed line indicates the route that the group drove towards where the avalanche occurred. The purpose of the detour was to look at an ice cave / formation at the foot of the mountain.**

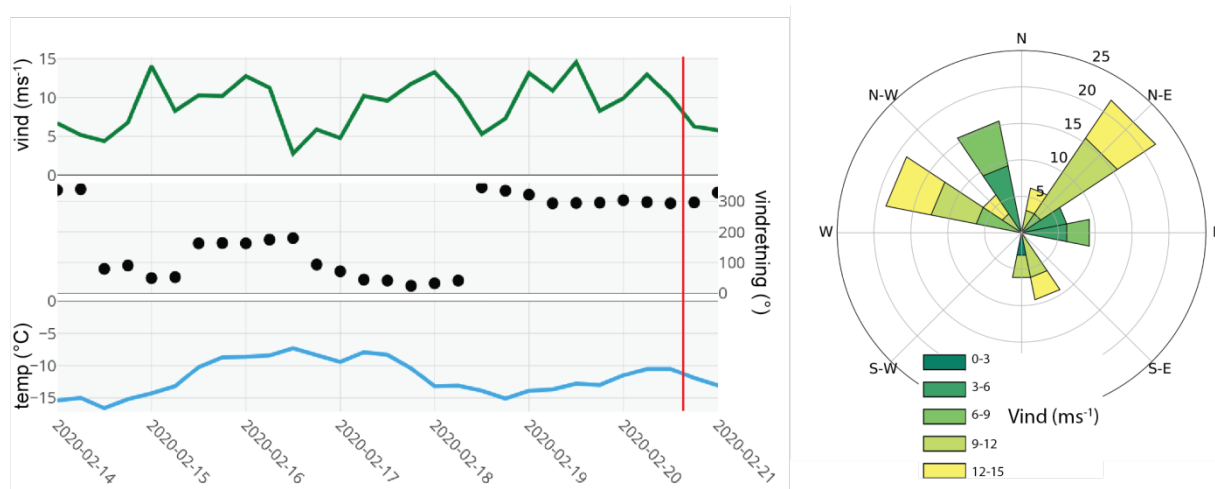
In the week before the accident, approximately 30 cm of fresh snow fell in the Grønfjordbreen area (west of Nordenskiöld Land, figure 5). Between the snowfall and the day of the avalanche, there have been several periods of strong winds from the northeast and west-northwest. On the evening of 16.02.2020, observations from Isfjord Radio show that the wind picks up and shifts from east to north-northeast direction. It can be assumed that the same was true for the Fridtjovbreen area. The wind calmed down in the morning of 18.02.2020 before shifting to west-northwest and increasing in the afternoon. The measurements show that there has been a strong wind mainly from the west-northwest in the last 48 hours prior to the time of the avalanche.

**Figure 4: Observations from Isfjord Radio for the week leading up to the avalanche. Measurements are at 6 hour intervals. The red line indicates approximately the time when the avalanche occurred. (Graphic: H. Hancock, UNIS).**

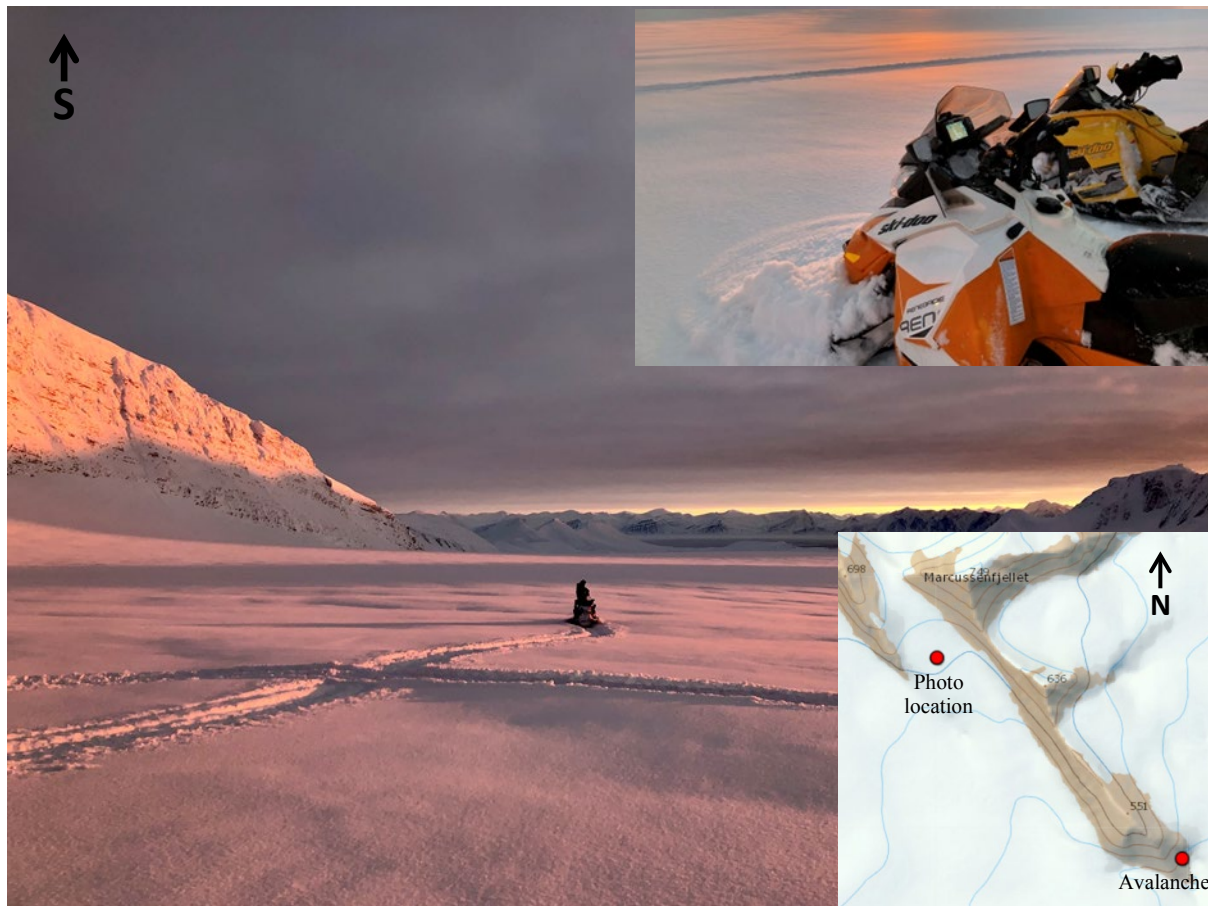
Figure 5: Photo taken on 16 February in the evening 2-3 km from the avalanche location in the pass at Marcussenfjellet on Fridtjovbreen. Approximately 30 cm of loose unbound snow on the glacier (Photo: Sara M. Cohen).

Information from a group that was on a snowmobile trip on Fridtjovbreen on 16 February shows that there was around 30 cm of fresh snow in the area (figure 5). They describe that there was more snow in the west of the region than in the vicinity around Longyearbyen. This fresh snow was taken by the wind over the next few days, and wind slabs built up on most slopes with east-south-west aspects due to changing wind directions and a lot of snow available for transport. The largest accumulation of snow onto the lee side slopes seems to have been in the 48 hours before the accident.

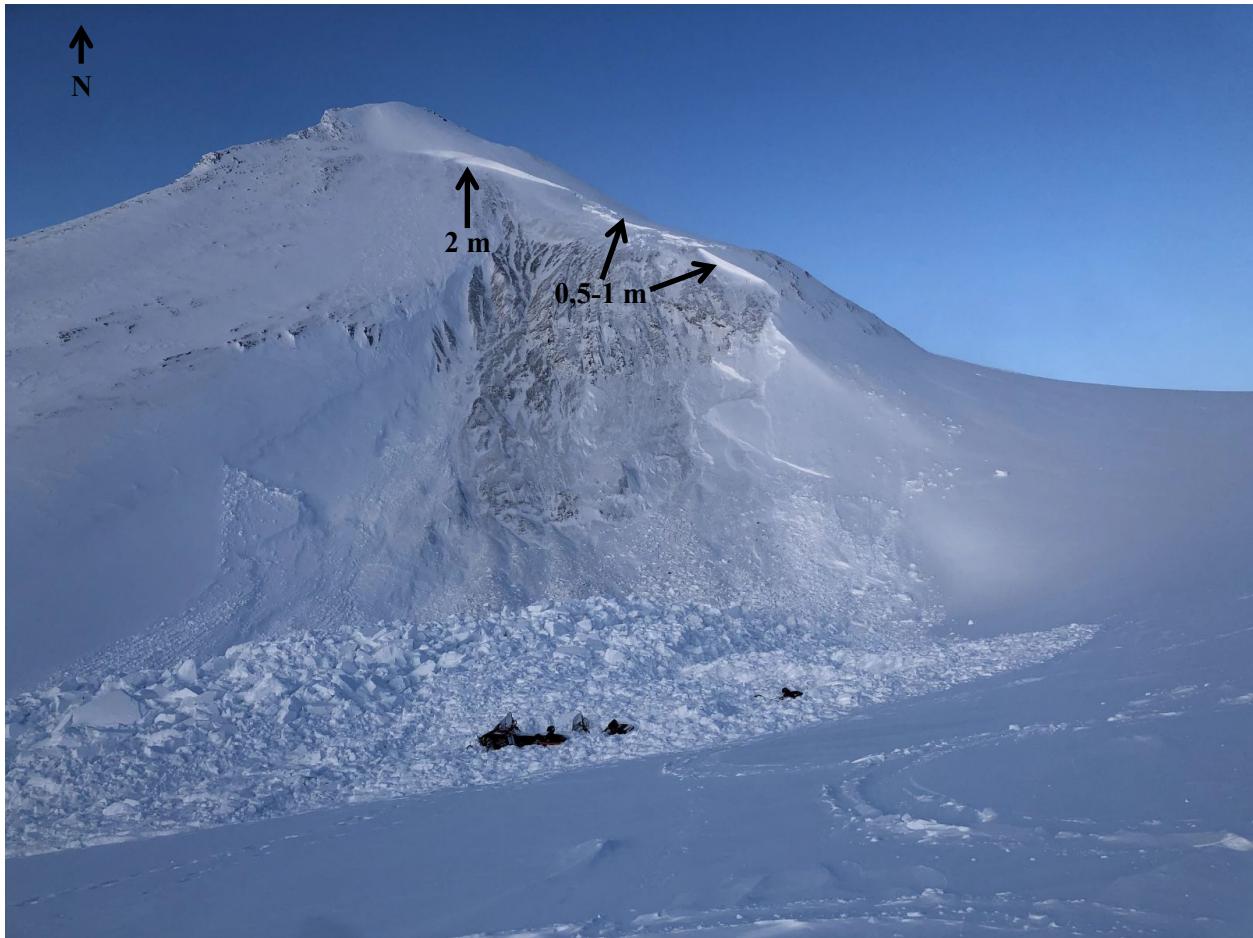
The avalanche was a dry slab avalanche of size 3 – large. It went from about 500 masl with aspect to the southeast and stopped at 450 masl in a depression on the glacier. The fracture is estimated to be between 0.5 meters and 2 meters tall (figure 9). The avalanche has a length of 300 meters from the crown to the avalanche runout. Because of the terrain formation with an abrupt transition between the mountain and glacier, the runout makes a turn to the southwest. The release area is estimated to have an area of 13.000 m<sup>2</sup> and the avalanche mass has an estimated volume of just under 10.000 m<sup>3</sup> (figure 8). The blocks in the avalanche debris were mainly between 0.5-1 m<sup>3</sup> with some blocks up to 2 m<sup>3</sup>. Due to the terrain, there has been a build-up of avalanche debris towards the east, somewhat smaller avalanche debris towards the avalanche runout where the two dead were found.

**Figure 9:** Photo taken the day after the accident. In the foreground you can see some of the snowmobiles that were partially covered by the avalanche. The crown is at most estimated at 2 m to the north and between 0.5-1 m to the east. The avalanche has gone all the way to the base in most of the avalanche path. (Photo: Sysselmannen of Svalbard).

The avalanche had several step-downs and appears to have occurred both on facets over the crust layer and on facets at the base (figure 9).

Based on this, it appears most likely that the group has triggered the avalanche remotely when they drove under the mountainside and into the runout area.

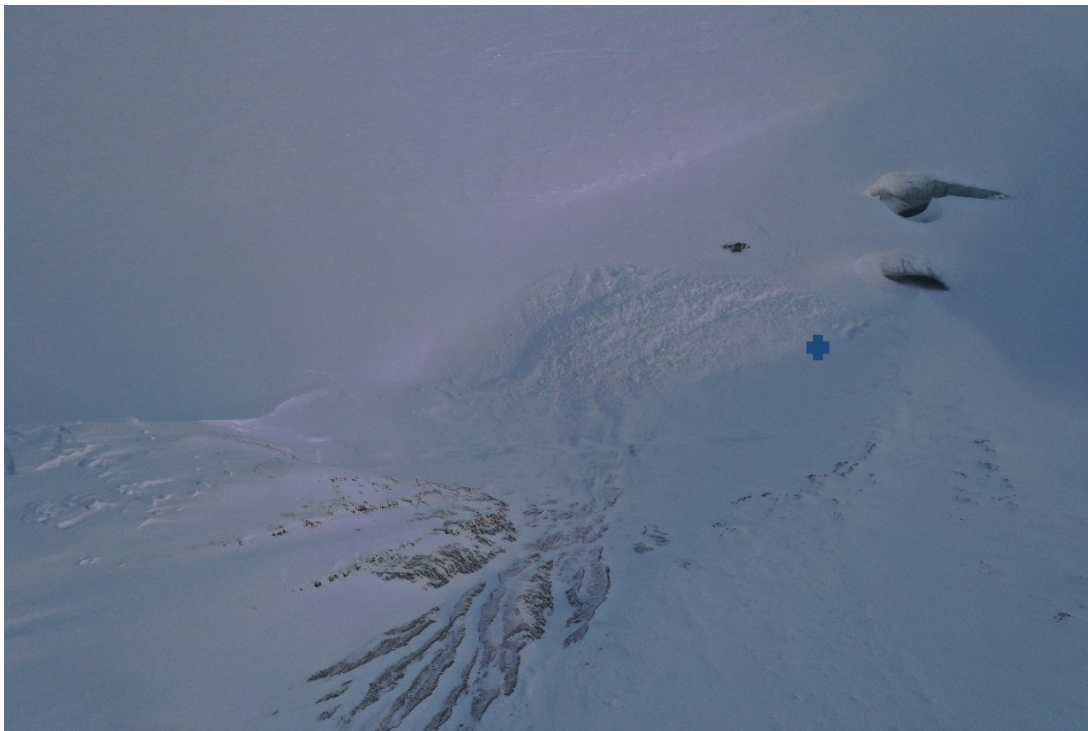
The release area is a steep slope between 35-40 degrees with southeast (SE) aspect. The avalanche path has a dip shape (from west to east) with a gully formation in the middle and the terrain is steepest in the middle of the avalanche path. The runout area has an abrupt transition from steep to flat terrain and a depression between the mountain and glacier. The avalanche debris have gone all the way to the base of the mountainside. The depression below the mountainside can be described as a small dip or valley (meltwater channel between mountain and glacier) and is lower in the terrain than the surrounding glacier. The dip is 15 degrees from east to west towards the open meltwater channel / ice cave in the glacier. The runout area can be described as a terrain trap, as there is an abrupt transition from steep to less steep terrain and will result in a collection of avalanche debris in the terrain (figure 10).

Figure 10: Drone image from 29 February, taken south and overlooking the avalanche path from the release area. To the right is the ice cave. Crosses indicate where the dead were exhumed. (Drone photo: Kjetil Slettnes).
